**Teatro 'La Fenice', Venice — The secrets of the
acoustical reconstruction of the destroyed theater
according to historical and modern requirements**

J. Reinhold

Müller BBM GmbH, Robert Koch Strasse 11, D 82152 Planegg/München, Germany
juergen.reinhold@muellerbbm.de

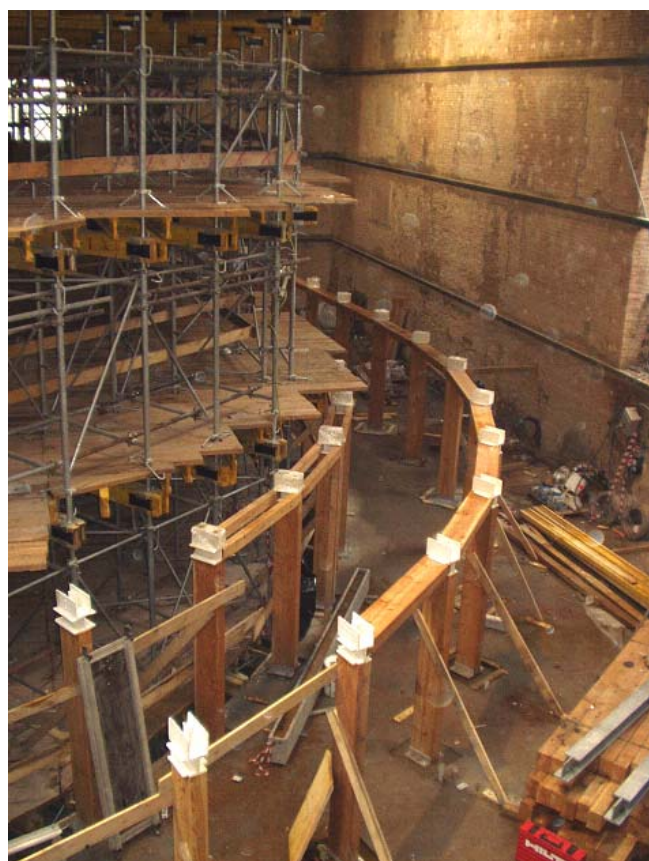
Separated wooden structure inside the *Cavea*'s brick walls

Both the load-bearing structures of the *Sala Teatrale* and the floors of the boxes are made solely from larch-wood beams, installed independently of the perimeter auditorium walls of the *Cavea*, which are built as solid brick walls. These wooden beams are also used as load-bearing elements for the entire wooden structure of the theatre ceiling.

This relatively light structure, rebuilt according to the original acoustical and constructive specifications, provides the basis for recreating the previous acoustic conditions of the *Teatro La Fenice*. This method of using a construction body made up exclusively of wooden elements is quite rare in theatres, but due to the self-supporting nature of the structure, detached from the rest of the building, it offers many acoustic advantages, such as low transmission of sound from the adjacent rooms. Furthermore, it is easy to excite this wooden structure to perceptible vibrations, such as those caused by the orchestra when playing *fortissimo*.

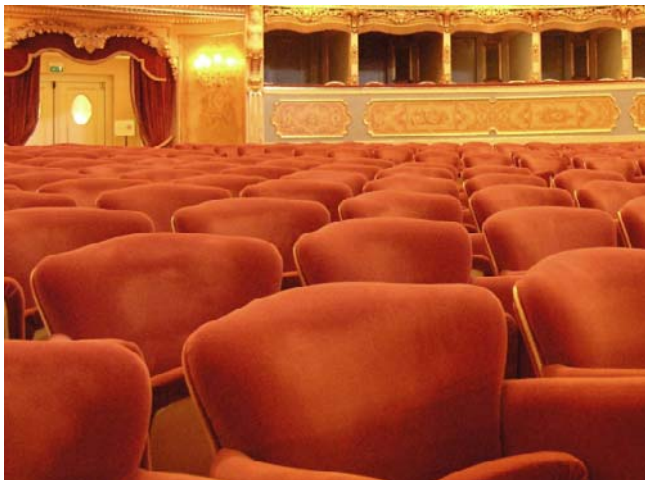
Newly constructed auditorium seats

With respect to the historic model, a seat was designed with a sound absorption capacity that would remain almost unchanged when the seat was either occupied or empty. This allows rehearsals to be carried out in an empty hall under acoustical conditions almost identical to those when the audience is present.

In addition, the absorbing surface area of the seats was limited to the necessary minimum. This meant reducing the sound absorption of the surfaces not affected by people's presence – the rear of the backrest and the sides – to the minimum. It was for this reason necessary to make some alterations – not visible from the outside – to the structure of the seat. Due to this detailed analysis and modification, the best possible acoustical properties could be achieved for the seats.

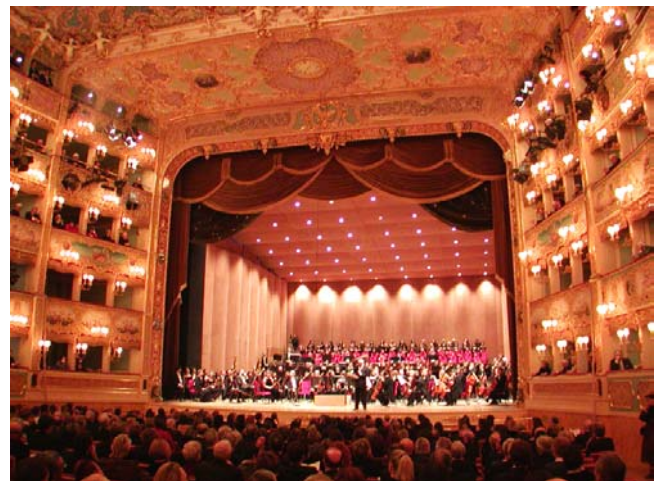
Orchestra shell on stage

With three walls plus the ceiling reflectors, the orchestra shell then forms the boundary towards the stage house. The shell also creates the reflections necessary for the acoustic contact between the musicians and allows the sound energy to be directed towards the audience rather than being mainly absorbed by the volume of the stage house.

The individual wall and ceiling elements of the orchestra shell allow great assembly flexibility and hence allow the shell to be adapted to the size of the orchestra. With the help of mobile wooden platforms, it is possible to vary the stepping and arrangement of the orchestra inside the orchestra shell.
